Report No. CG-D-50-77

ESTIMATE OF THE POTENTIAL BENEFIT
OF THE PRESSURE RELIEF VENT/FLAME
DEFLECTOR CONCEPT
USING IN-DEPTH ACCIDENT INVESTIGATION

FINAL REPORT

Prepared for
U. S. DEPARTMENT OF TRANSPORTATION
UNITED STATES COAST GUARD
Office of Research and Development
Washington, D.C. 20590

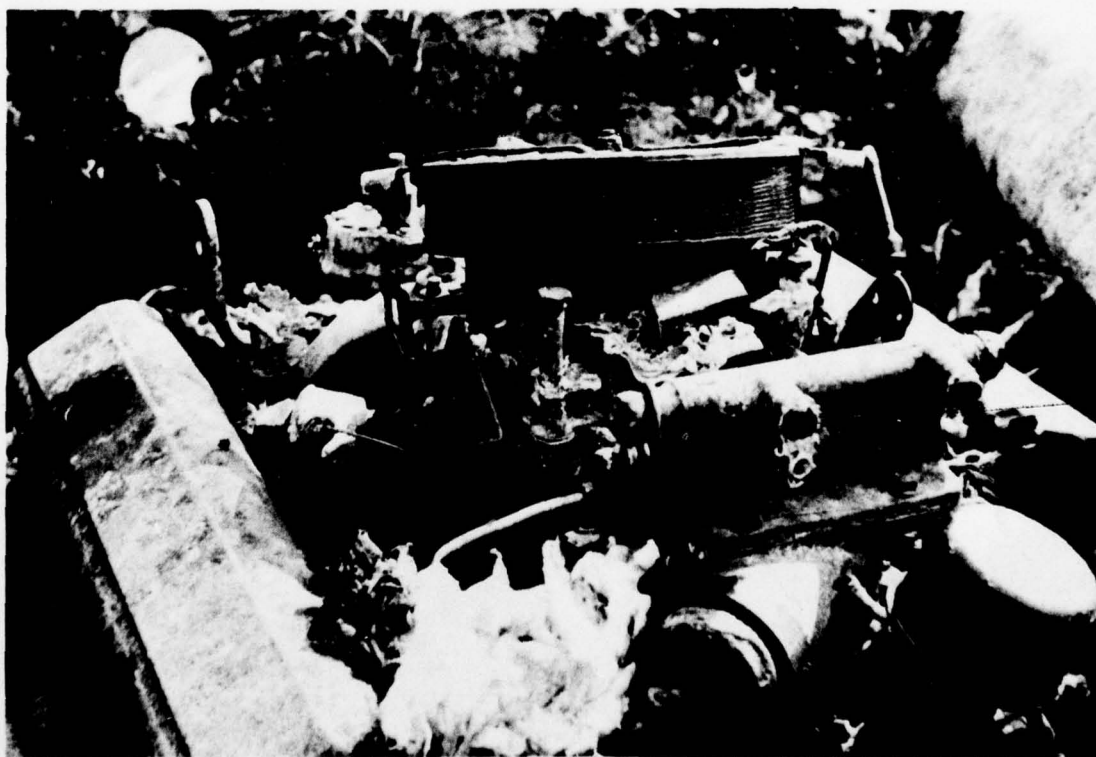
As can be seen from the photos, there wasn't much left of the boat. The carburetor and back-fire flame arrestor seemed to be in good shape. Evidence showed that there was a continuous supply of gas in the bilge, so the carburetor was discounted as the source of the fuel leak.

Figure 3 Carburetor and Flame Arrestor

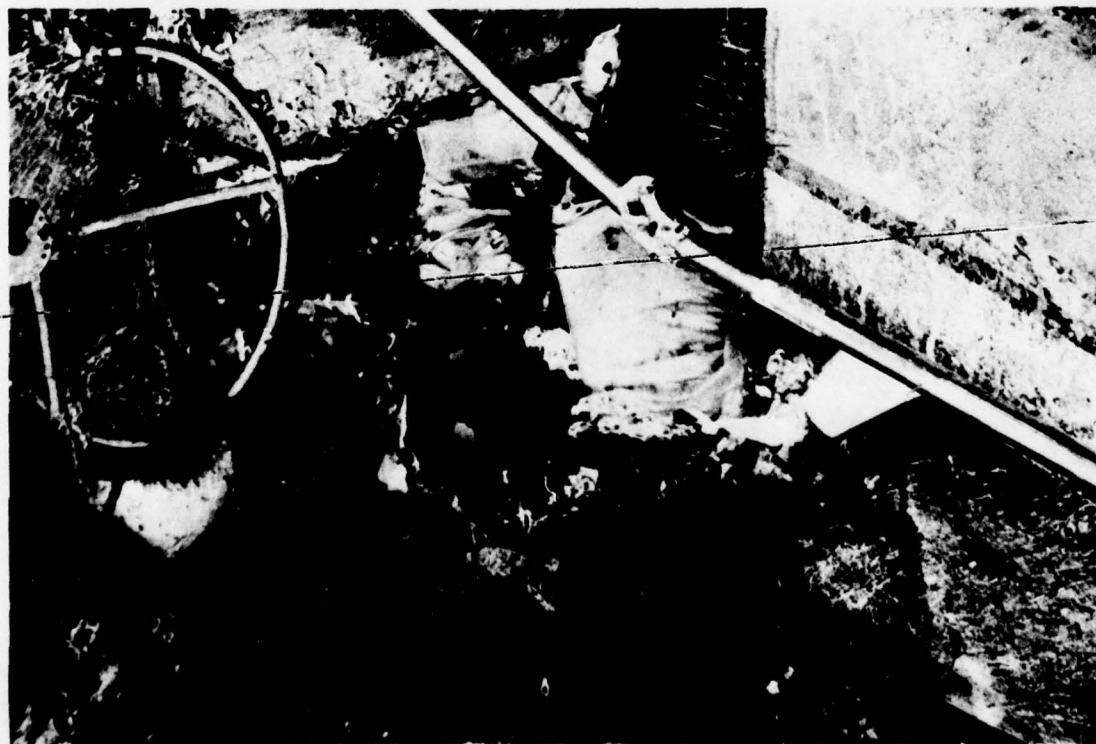
Figure 5 10 lb Fire Extinguisher And Remains Of PFD

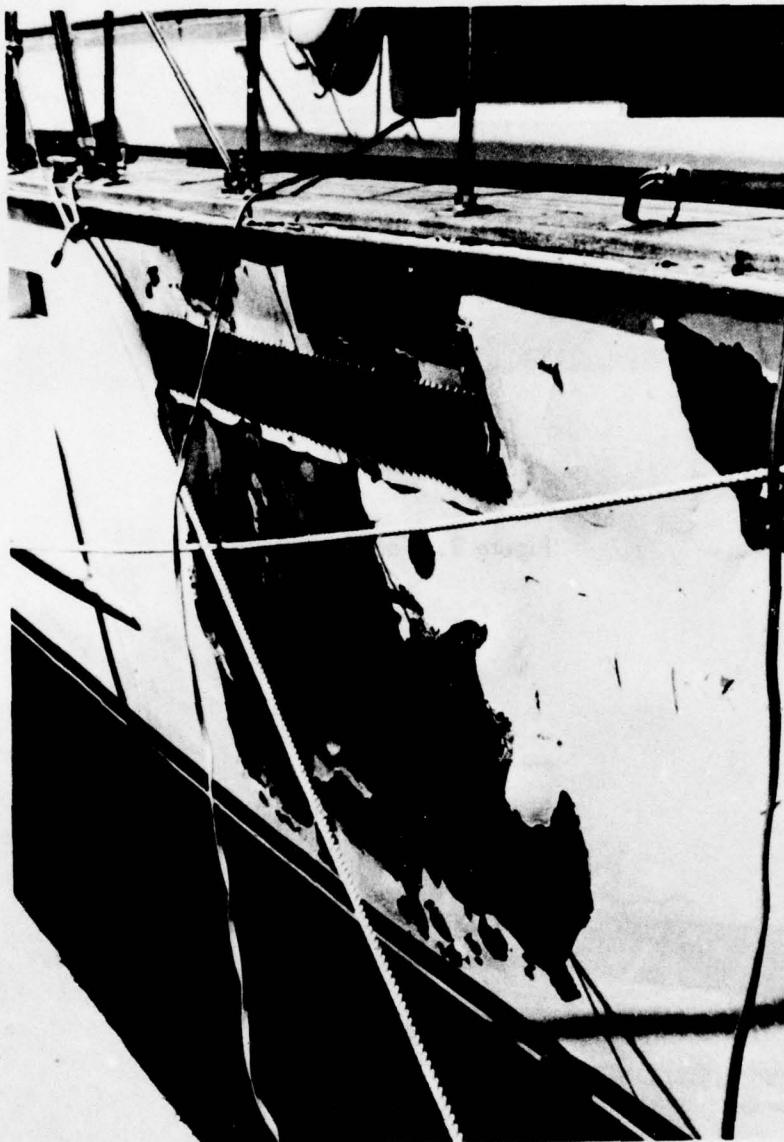
Figure 5. Exterior Damage - Starboard Hullside

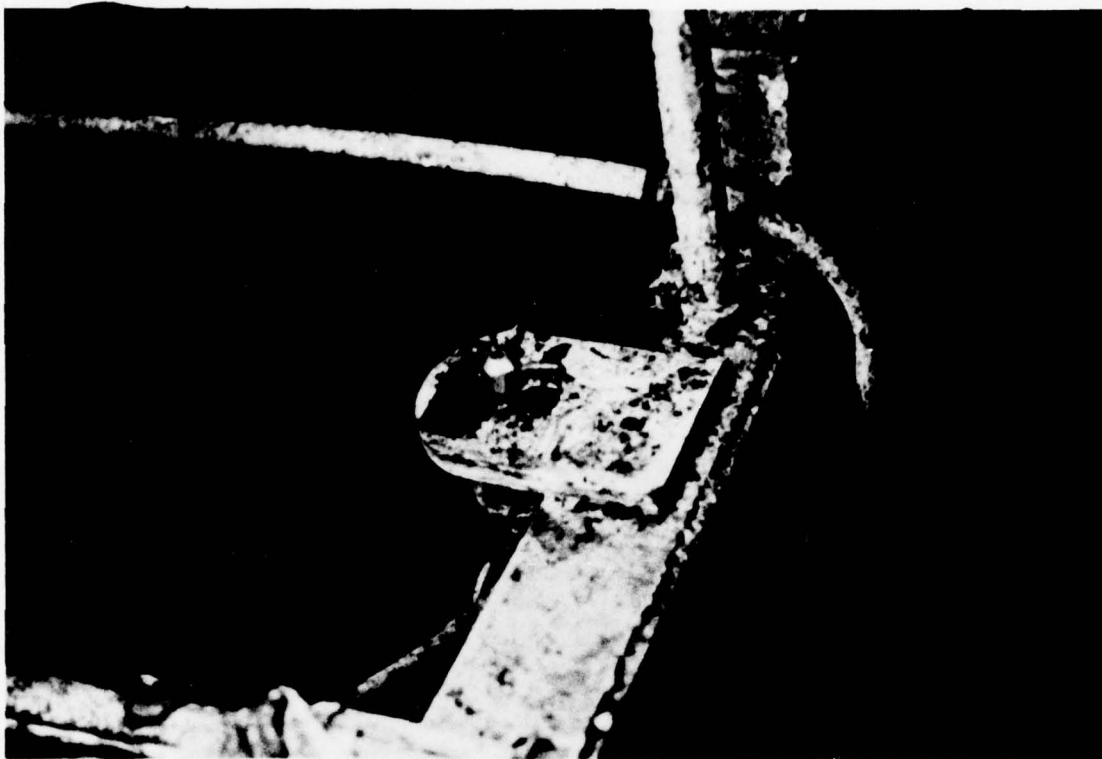
Figure 6. Battery Disconnect Switch

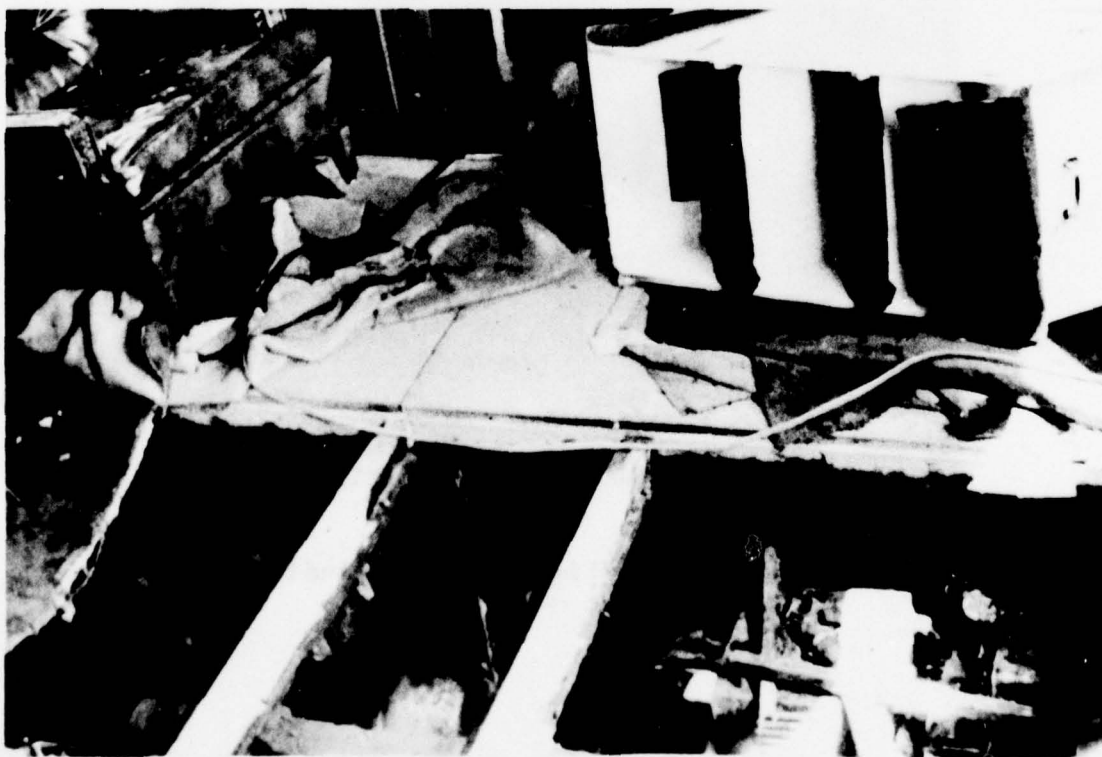
Figure 7. Salon, Showing Stair/Hatch Now Broken And Laying On Salon Floor

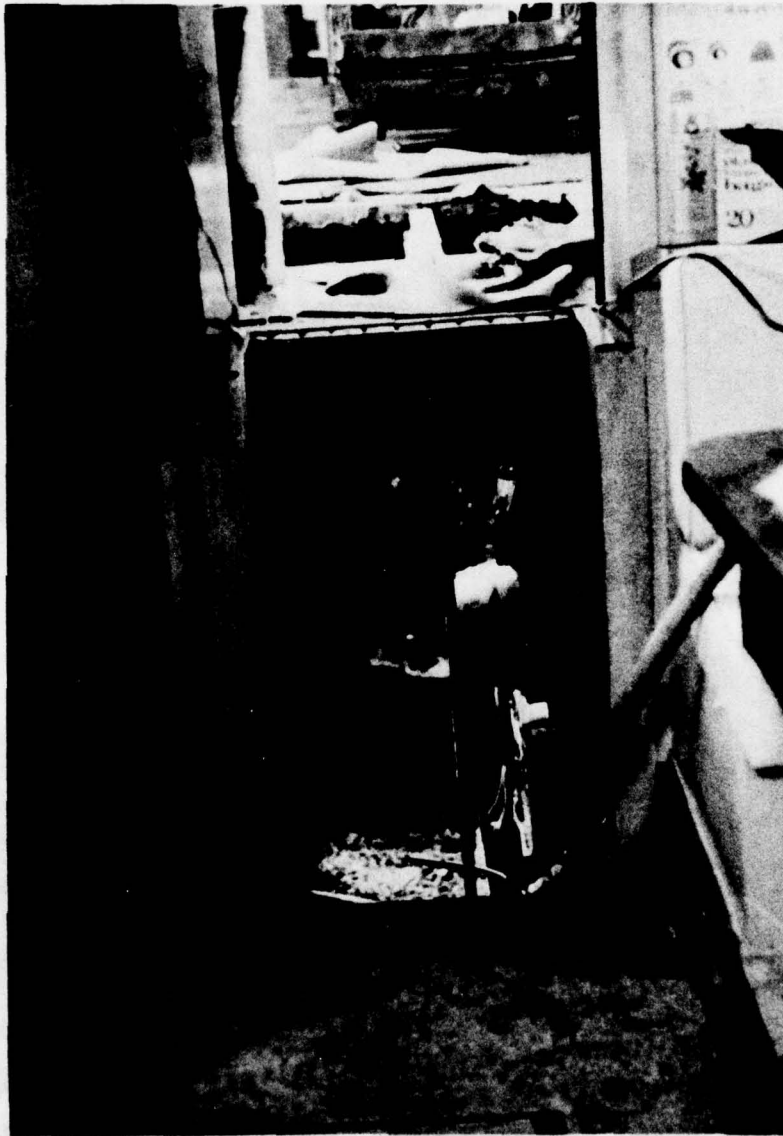
Figure 8. View From Galley, Aft Into Salon Above And Engine Room Below

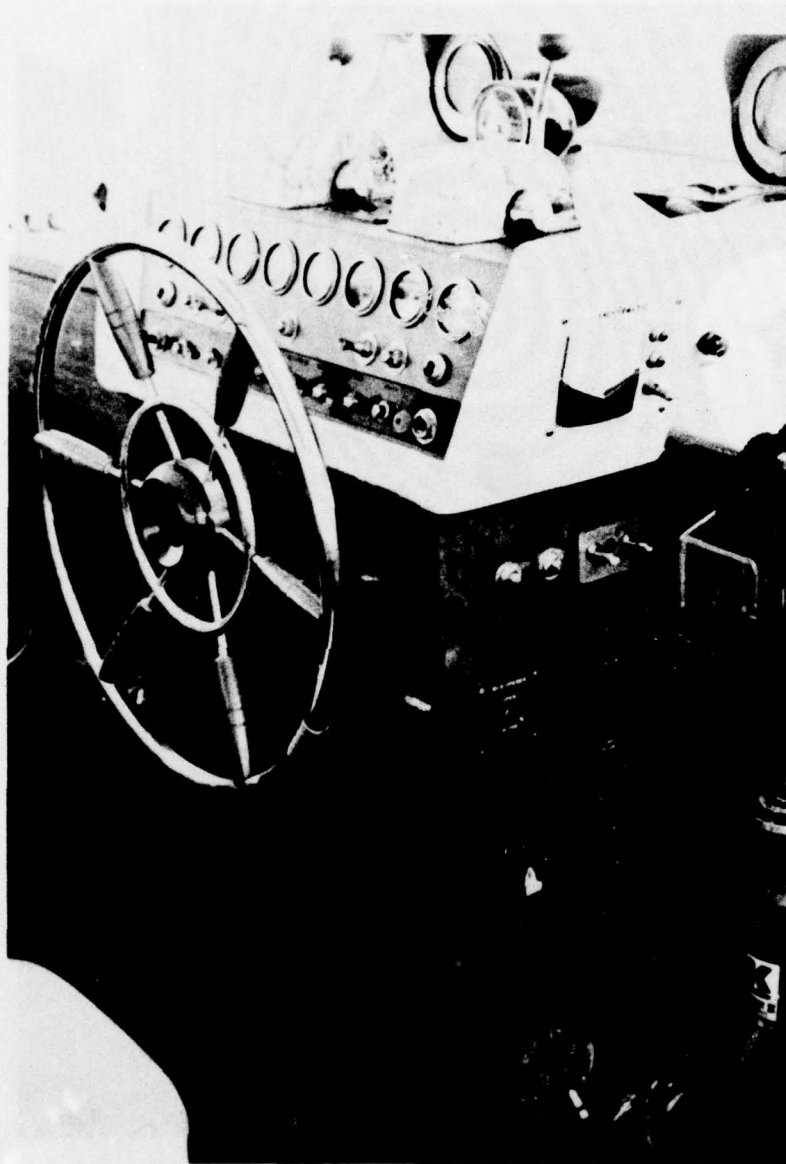
Figure 9. Control Console — Note Automatic Fire Extinguishing System Handle Pulled. (Bottom side of console) Ammeters Are Middle Two Gauges

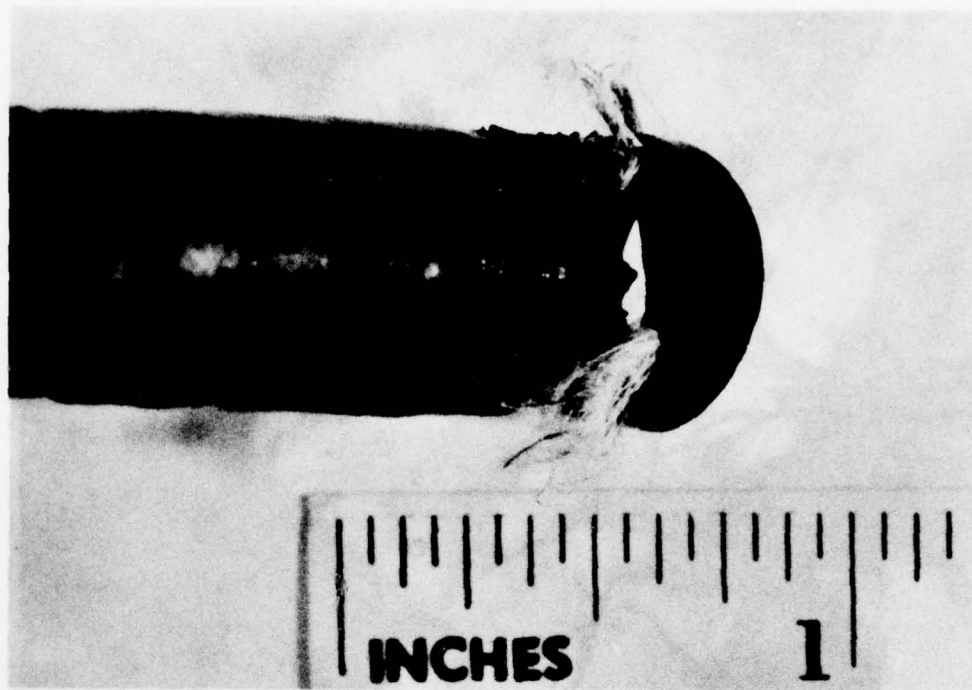
Photograph 9. Ruptured Fuel Line

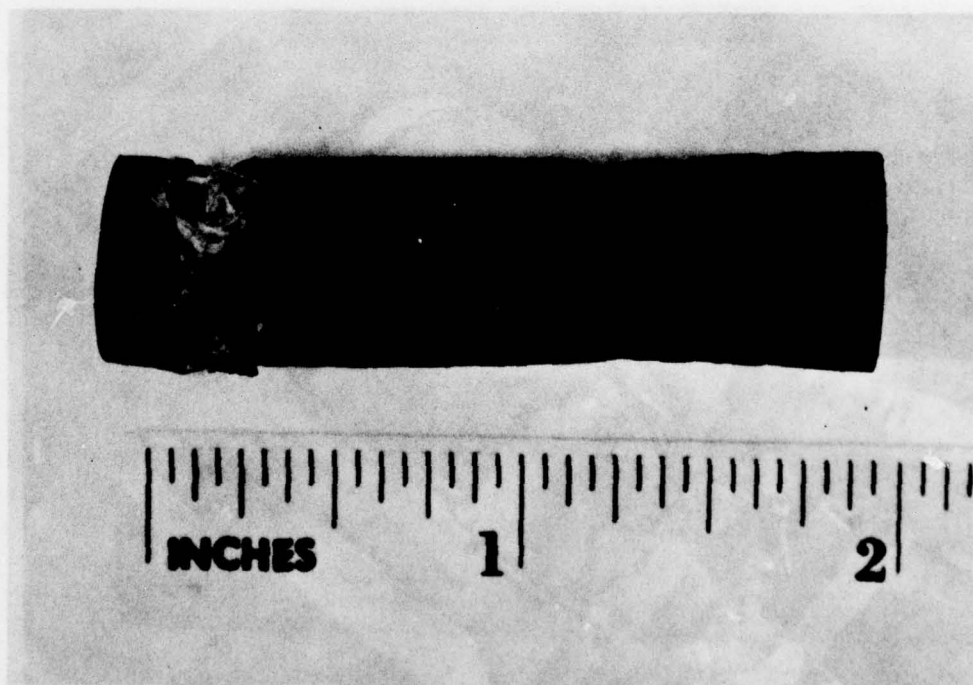
Photograph 10. Ruptured Fuel Line

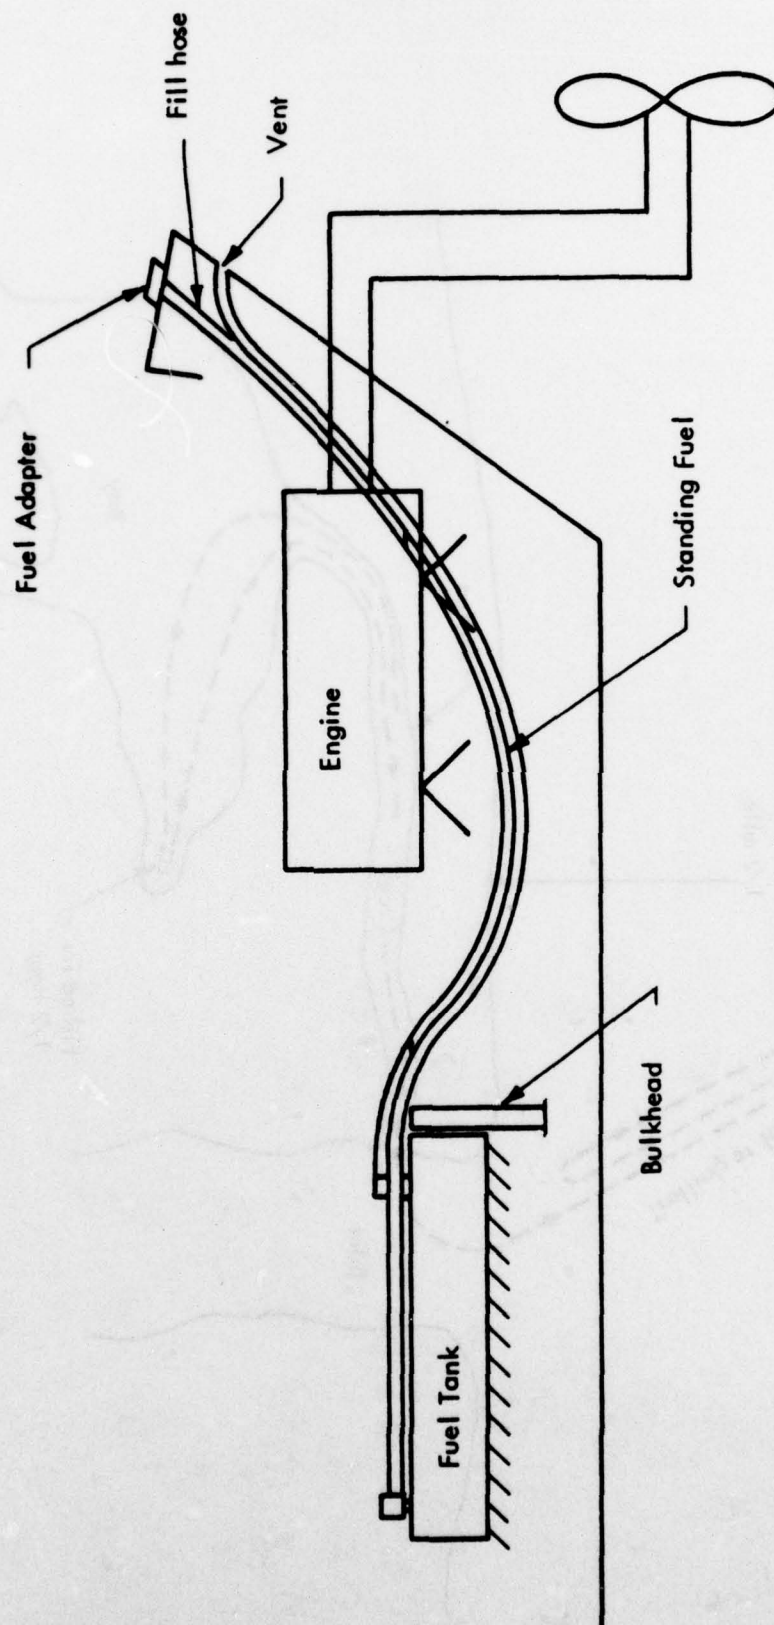
Figure 3. Fuel Line Routing
